THE CITY OF MISSION HILLS

MISSION HILLS STORMWATER MASTERPLAN

Part I – Open Channels
Channel Degradation Assessment
and
Recommended Improvements

February 13, 2007

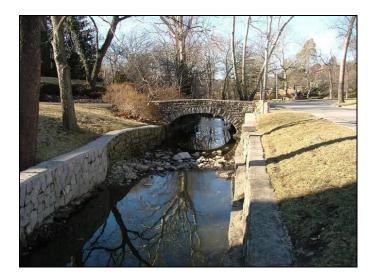
Type 3 – Restorable (± 1 SD from mean). Deterioration of the riparian corridor is more noticeable. While some remnant plant associations may be present, overall

vegetative canopy cover is comprised of immature tree species. The potential for restoration exists although erosion and sedimentation can be greater than desirable.

Photo 6. Type 3, Restorable stream.

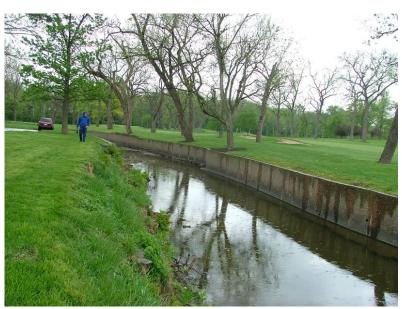
Type 4 - Low Quality (-2 SD from mean). Impacts are greater on this stream type with significant indicators of bank erosion and sedimentation present. The adjoining riparian corridor may be intact but vegetation is not representative of a native plant association.

Photo 7. Type 4, Low Quality.

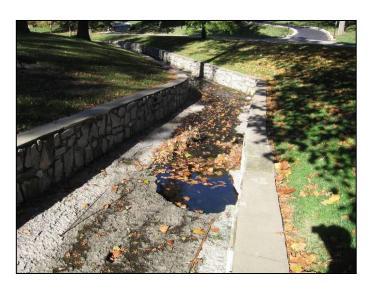
The most stable channels include the ones lined with grouted stone walls and concrete bed. These channels, however, do not have a higher rating because the banks are stable as long as the concrete and walls provide the required protection. Concrete lined channels, can become unstable overtime if the concrete is eroded by the abrasive action of high velocity flows. If not maintained, once the concrete lining on the bed is lost, streambed degradation will progress at a rapid pace and the wall foundations will be compromised. Without the concrete and the walls the stream will be extremely unstable, especially if no vegetation protection exists on the banks.

Photo 8. Concrete channel in poor conditions.

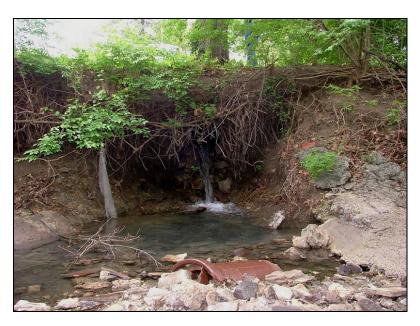
Stream reaches 271, 201, 220, 56 and 57 are the least stable. The instability appears to be the result of serious bank or retaining wall failure along high stream banks. In the case of reach 220, which is the longest natural channel reach studied, the east streambank has been lined with slabs of concrete, asphalt, and other debris to prevent erosion and collapse of the parking lot located along the top of the bank. This hard surface reinforcement is not stable and is resulting in an increase in water velocity through this reach which in turn results in a higher erosion potential.

Photo 9. Outfall structure in poor conditions.

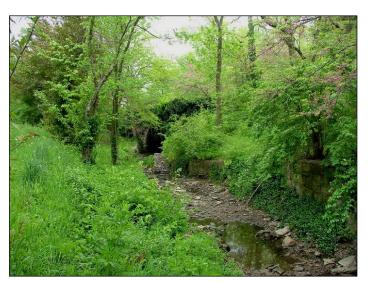
Stream reach 220 has the highest score for aquatic habitat. This is most likely due to the length of the reach having been left relatively natural, and the presence of a mix of macrohabitat types (pools, riffles, and runs) present. The lowest aquatic scores are associated with channels lined with concrete and grouted stone walls and where habitat structure is negligible. Examples of reaches with low aquatic score reaches are: 7, 8, 60 and 270.

Photo 10. Stream with vegetation and in-stream habitat.

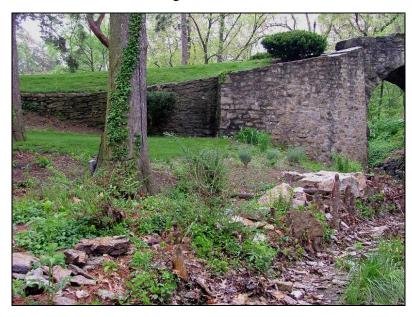
It was interesting to note the presence of cypress knees (Bald cypress roots extending above ground in areas of saturated soils) along reach 202. The presence of these knees indicates that the soils along the stream channel are staying saturated with water for extremely long periods of time. This is a unique feature that is generally not encountered in as dry a climate as that associated with the Kansas City region. Another interesting note is the condition of the tributary flowing into Brush Creek at the northwest end of reach 50. This reach has a road along the east side and a golf course along the west side. Most of the vegetation within the golf course is highly maintained even down some of the streambank slopes. However, the tributary appears to have a relatively healthy mix of vegetation and the stream channel appears to be in better condition than the main channel it is flowing into.

Photo 12. Bald Cypress Knees
